**CAPRON TRAIL
COMMUNITY DEVELOPMENT
DISTRICT**

**ST. LUCIE COUNTY
REGULAR BOARD MEETING
MAY 20, 2024
1:30 P.M.**

**Subject: Year 2024 Above Ground Impoundment (AGI) Inspection Report
Capron Trail Community Development District
St. Lucie County, Florida
Permit No. 56-00745-5**

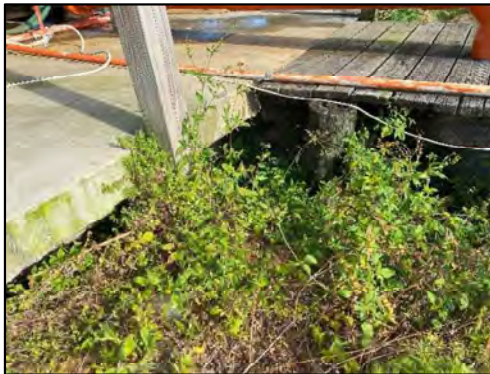
- b) At the location of the pump station on the West Levee, some undermining of foundation soils was noted at the wooden ramp.

Photo 2 - South Reservoir - West Levee. Undermining Below the Pump Station Slab at Wooden Ramp

- West Levee - at the pump station location, the undermined area beneath the wooden ramp should be backfilled with soil, with cement bags forming barricades as needed.

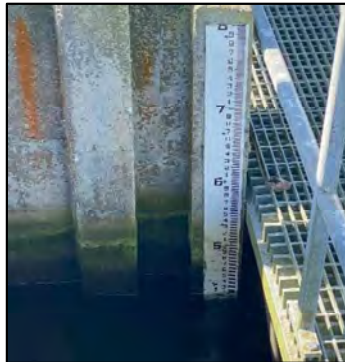
- a) The main spillway located on the East Levee which discharges into the C-1A southeast-northwest canal that abuts the reservoir was observed. The gauge on the spillway was observed to be in good condition and the reservoir water elevation reading on the gauge was approximately 29.2 feet (NGVD) on the day of our inspection which is about 4.8 feet below the crest of the levee. The levee slope at the west end of the C-1A canal is protected with a concrete mat. No sinkholes, potholes, or depressions were noted above the buried spillway pipe in this area of the levee.

Photo 4 - South Reservoir. Water elevation gauge on main spillway.

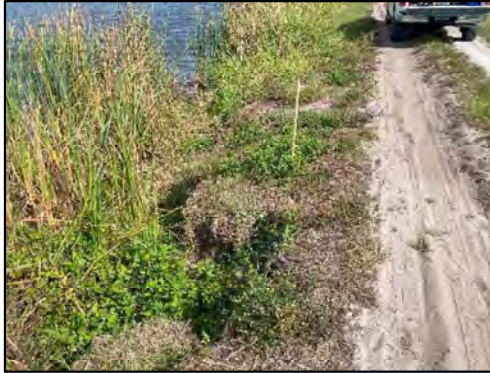
- b) Near the center of the East Levee, we noted an approximate 30-foot-long area of wave erosion on the inside of the levee. A wooden stake with the designation “Area #1” was placed on the west side of the crest road at this location.

Photo 5 - South Reservoir. Erosion Area Near Center of East Levee

- East Levee - repair the small area of wave erosion on the inside of the levee near the center of the levee (wooden stake "Area #1" placed at this location) as well as the small area of wave erosion noted just north of Area #1 (wooden stake "Area #2" placed at this location). We recommend repairing these areas by clearing the vegetation, determining the slope, then placing fill soil as needed to restore the slopes. The fill soil should be tamped with the excavator bucket as placed.

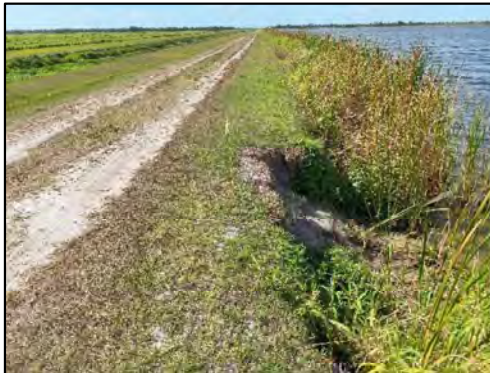
- c) Just north of the area identified in Photograph 5 above along the East Levee, we noted an additional approximate 12-foot-long area of wave erosion on the inside of the levee. A wooden stake with the designation “Area #2” was placed on the west side of the crest road at this location.

Photo 6 - South Reservoir. Erosion Area Just North of Area in Photo 5 (East Levee)

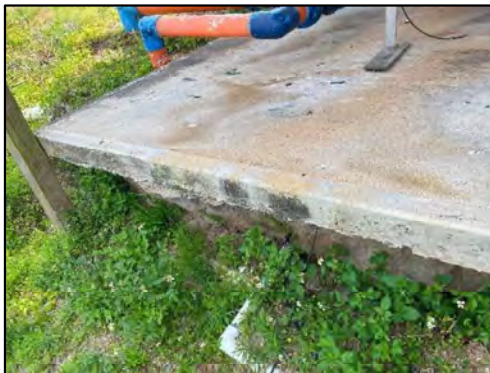
- d) The pump station located near the center of the East Levee was observed. Some undermining of foundation soils was noted at the northwest corner of the pump station slab. This undermining has been noted during previous inspections.

Photo 7 - South Reservoir. Undermining of Pump Station Slab on East Levee

- East Levee - the undermined area beneath the northwest corner of the pump station slab should be backfilled with soil, with cement bags forming barricades as needed.

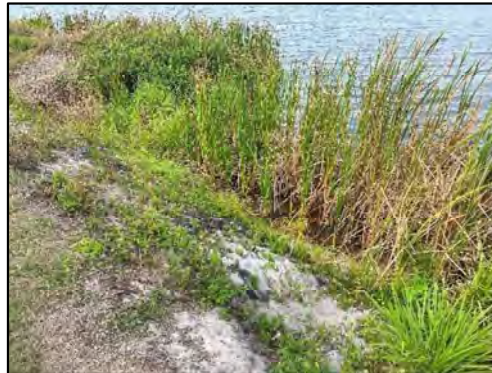
- e) The emergency morning glory (S-5A) spillway formed by a vertical corrugated metal pipe is located in the northern portion of the East Levee. The water in the reservoir was about 14 inches below the rim of the spillway standpipe at the time of the 2024 inspection. On the day of the inspection, the area around the spillway had become overgrown with vegetation and we recommend that the vegetation immediately around the spillway be cleared. The discharge pipe for this emergency spillway is submerged in the eastern perimeter drainage canal. There were no obvious signs of depressions or sinkholes noted in this levee area above the spillway discharge pipe on the day of our inspection.

Photo 8 - South Reservoir. Emergency spillway riser in north portion of East Levee (obscured by vegetation)

- East Levee - the vegetation should be cleared away from the emergency morning glory (S-5A) spillway structure located on the north portion of the East Levee.

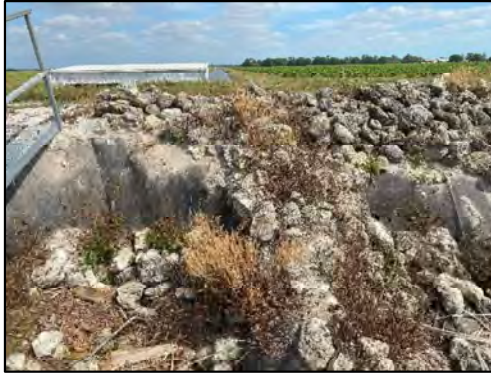
- b) The slope around the main intake (PS-1) pump discharge pipes located near the middle of the North Levee has been protected with rip rap armor. On the day of our inspection, we noted that some of the rip rap is starting to move down the slope exposing the geotextile fabric. No obvious signs of depressions or sinkholes were noted in the immediate vicinity of the pump intake on the day of our inspection.

Photo 10 - South Reservoir. PS-1 Pump Discharge Pipe Location on North Levee

- North Levee – At the location of the main intake (PS-1) pump discharge pipes, rip rap should be placed on portions of the inside slope where the underlying geotextile fabric is becoming exposed.

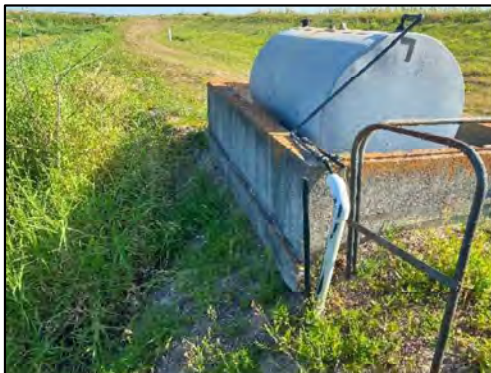
1. There is good grass cover on the outside slopes of the levees on each side of the South Reservoir.
 - a) The toe of the levee was improved in 2017-2018 with an approximately one-foot-deep re-established ditch (toe ditch) connecting the intake pipes of the toe drains, so that most of the toe area is relatively dry and firm for most of the time. The reworked ditch is occasionally deeper than the level of the slots in the vertical pipe connected to the horizontal toe discharge pipe, which causes a minor ponding of water around some intake pipes.
2. West Levee
 - a) Along the West Levee the outer surface of the levee was generally dry and in good condition.
 - b) At the location of the reservoir discharge pipe located on the south portion of the West Levee, some undermining of foundation soils was noted at the diesel fuel tank slab located on the outside of the levee.

Photo 11 - South Reservoir. Undermining Below the Diesel Fuel Tank Slab

- West Levee - at the location of the reservoir discharge pipe located on the outside of the south portion of the levee, we recommend that the undermined area beneath the diesel fuel tank slab be backfilled with soil, with cement bags forming barricades as needed.

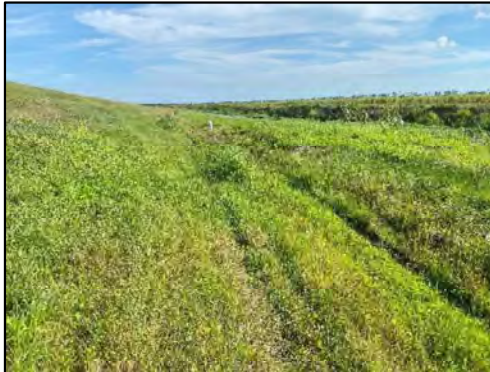
- a) The perforations in standpipes of the toe ditch are occasionally higher than the level of the bottom of the toe drain, so that there is an accumulation of water in the bottom of the toe ditch in some areas, but the adjacent slopes are generally firm.
- b) Along the south portion of the East Levee in the areas near Standpipes #25 to #30 and #32, minor rutting of the levee surface adjacent to the toe ditch has occurred due to the water accumulating in the toe ditch.

Photo 12 – South Reservoir – Rutting Noted Next to East Levee Toe Road

- East Levee - we recommend reshaping the toe ditch on the outside of the levee in the area near and between Standpipes #25 to #30 and #32 to allow water to flow to the standpipes in this area and prevent future rutting.

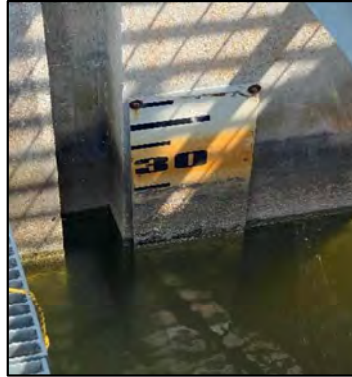
- b) The main spillway structure located at the southeast corner of the east section of the reservoir discharges into a canal to the southeast of the reservoir. There were no obvious sinkholes or depressions noted during the inspection between the intake and discharge ends of this pipe. The spillway structure has a staff gauge to mark the level of the water in the reservoir. At the time of our inspection, the water level inside the reservoir was at an elevation of about 28.6 feet (NGVD) according to the staff gauge.

Photo 14 – North Reservoir. Main Spillway Staff Gauge on April 2, 2024.

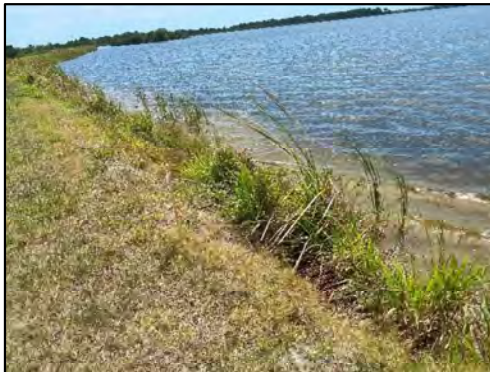
- a) Near the center of the North Levee, we noted an approximate 50-foot-long area of bare vegetation and signs of early wave erosion on the inside of the levee. A wooden stake with the designation “Area #3” was placed on the south side of the crest road at this location. Several similar small areas of sparse vegetation and early wave erosion were noted between this area and the pump shed to the west.

Photo 15 - North Reservoir. Bare Vegetation and Early Erosion Area Near Center of North Levee

- North Levee - repair the areas of sparse vegetation growth and early wave erosion on the inside of the levee beginning near the central portion of the levee (wooden stake "Area #3" placed at this location) and extending to near the pump station. We recommend repairing these areas by clearing the vegetation, determining the slope, then placing fill soil as needed to restore the slopes. The fill soil should be tamped with the excavator bucket as placed.
- South Levee – South "Compartment" - the rutting noted near the toe ditch on the outside of the levee should be repaired and the toe ditch reshaped in this area to allow the water to drain to the ditch.

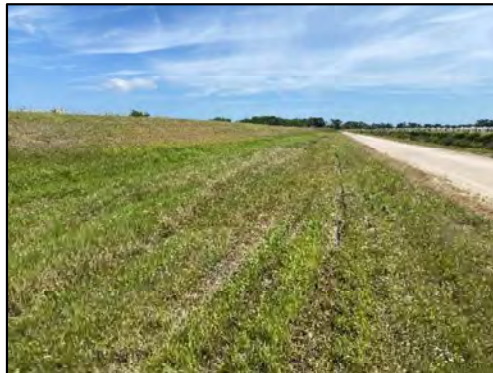
- a) The lower portion of the slopes of the levee at the northwest compartment are relatively dry, with no obvious signs of significant seepage, and are in good shape.
- b) Some minor rutting due to wet conditions from the toe ditch holding water was noted during our inspection near the west end of the levee at the south compartment.

Photo 18 - North Reservoir. View of minor rutting near toe ditch on South Levee at the South Compartment.
