**CAPRON TRAIL
COMMUNITY DEVELOPMENT
DISTRICT**

**ST. LUCIE COUNTY
REGULAR BOARD MEETING
MAY 20, 2024
1:30 P.M.**

**Subject: Year 2024 Above Ground Impoundment (AGI) Inspection Report
Capron Trail Community Development District
St. Lucie County, Florida
Permit No. 56-00745-5**

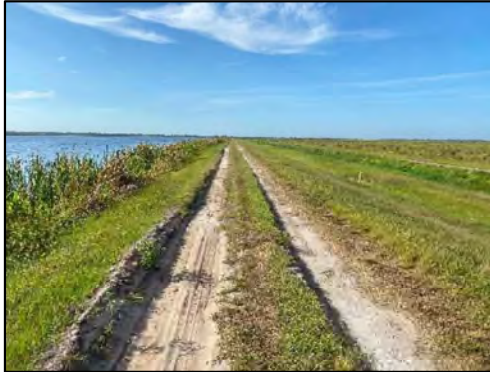
- a) Typical view of the West Levee is presented below. No significant issues were noted along the crest and inside slope of the West Levee.

Photo 1 - South Reservoir. General View of West Levee

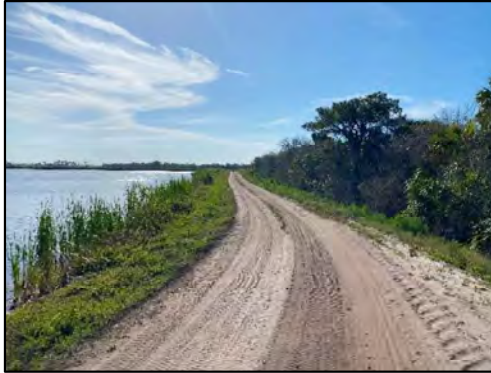
- a) Typical view of the South Levee is presented below. No significant issues were noted along the crest and inside slope of the South Levee.

Photo 3 - South Reservoir. General View of South Levee

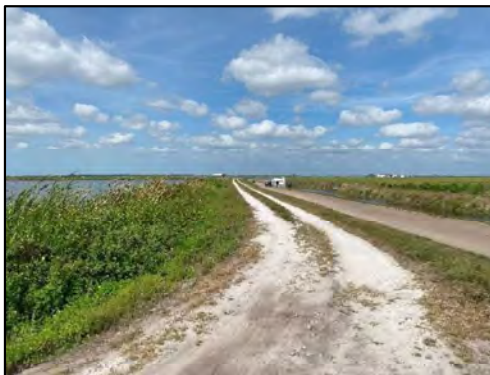
- a) Typical view of the North Levee is presented below. No significant issues were noted along the crest and inside slope of the North Levee.

Photo 9 - South Reservoir. General View of North Levee

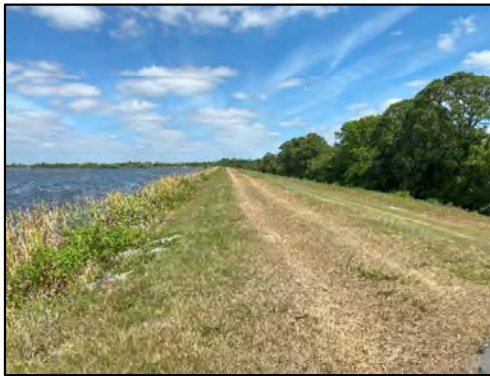
- a) Typical view of the East Levee is presented below. No significant issues were noted along the crest and inside slope of the East Levee.

Photo 13 - North Reservoir. General View of East Levee

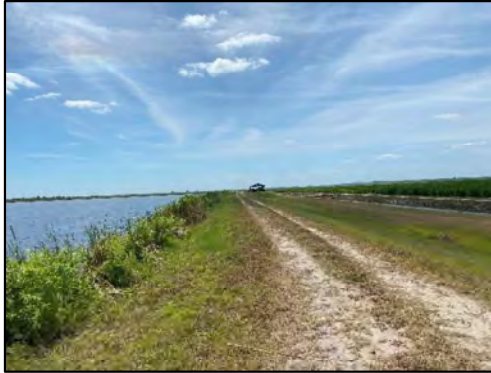
- a) Typical view of the West Levee is presented below. No significant issues were noted along the crest and inside slope of the West Levees along the northwest and south compartments.

Photo 16 - North Reservoir. General View of West Levee

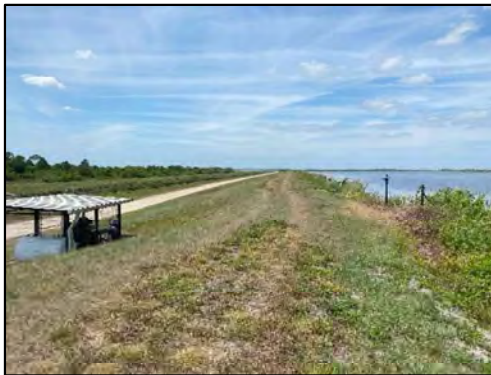
- a) Typical view of the South Levee is presented below. No significant issues were noted along the crest and inside slope of the South Levees along the northwest and south compartments.

Photo 17 - North Reservoir. General View of South Levee
